Manhole Inspection Summary

Manhole # S23KK1018MH

Insp Date: **11/21/06 10:59 AM**

Location Address: **4434 FALLS RD** Cross Street: **COLD SPRING LN**

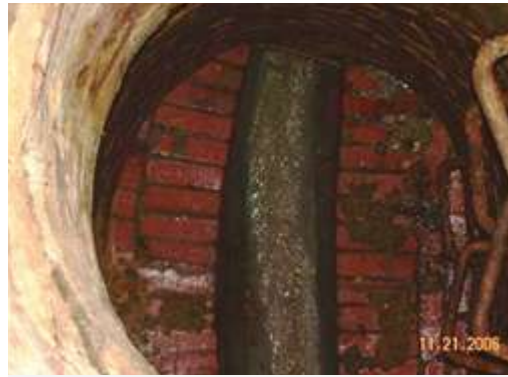
Top View

Adjustment deterioration and infiltration.
Evidence of surcharge - Bench debris.
Corroded steps

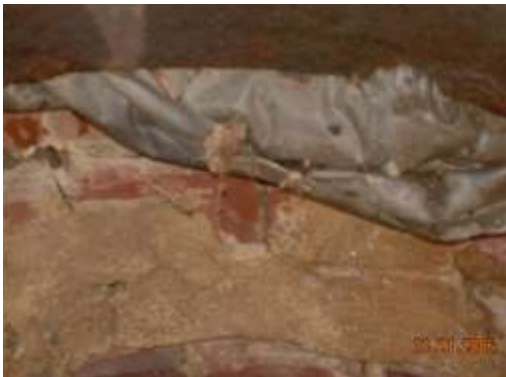
Defect

Frame leaks. Adjustment deterioration
and infiltration.

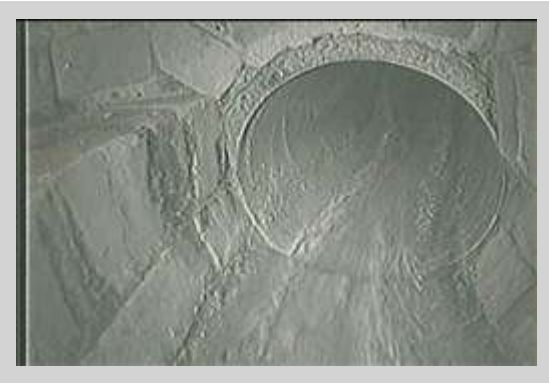
10 in. Circular Gravity Sewer Pipe Out @ 12 O'Clock

Infiltration: **Evidence** Pipe Seal Cond: **Unknown**

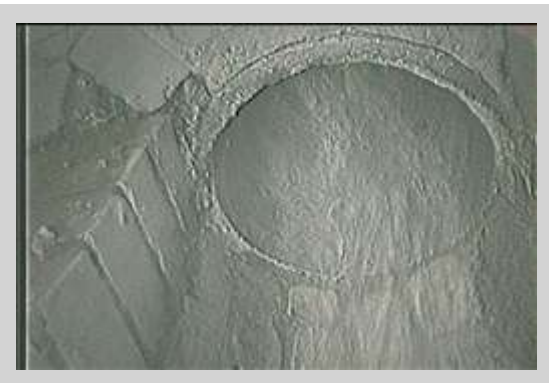
10 in. Circular Gravity Sewer Pipe In @ 5 O'Clock

Infiltration: **Evidence** Pipe Seal Cond: **Unknown**

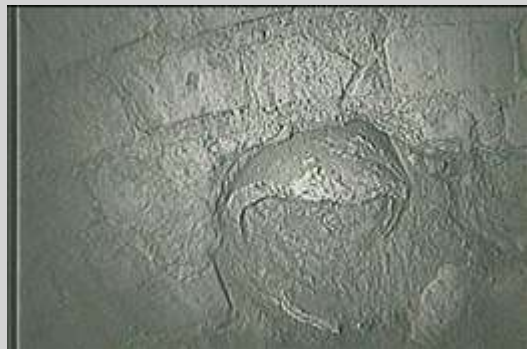
6 in. Circular Gravity Sewer

Connects To: **Stub connection / abandoned**
